State of California — The Resources Agency
DEPARTMENT OF PARKS AND RECREATION
PRIMARY RECORD

Page 1 of 1 Resource name(s) or number (assigned by recorder) *36-903 Palm View Drive*

*c. Address *36-903 Palm View Drive*

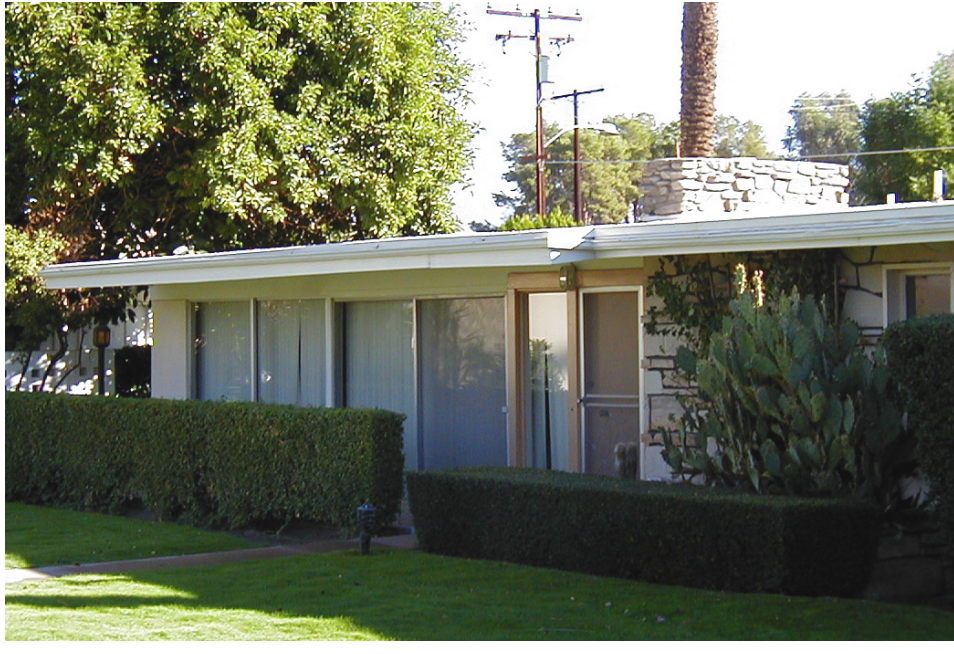
P5a. Photo

This property is one of the Tamarisk Ranchos cluster of 16 single-family residences, designed by the in-house architects for developer Lou Halper's Devon Construction Company in 1958. Although each one-story house is free-standing, they share a cooperatively-owned central park and swimming pool area towards which all of the residence's rear elevations face. The cluster is located one block east of the Tamarisk Country Club golf course. The 36-903 Palm View Drive residence has a flat roof covering 1,901 interior square feet with three bedrooms and 2.5 bathrooms. Exteriors are sheathed in medium-smooth stucco and natural rock. Deep eaves shade most elevations. Windows are tall and narrow south of the rear entrance and floor-to-ceiling fixed and sliding to the north. A natural rock interior chimney emerges from the living room. The meticulously maintained park-like grounds include vast lawns, trimmed hedges, and a virtual grove of mature date palms. The house is mostly original and in excellent condition. The property would contribute to a potential historic district that could be designated under an existing or proposed local ordinance (a "5D1" National Register Status Code).

*West elevation
November 2002*
