State of California — The Resources Agency  
DEPARTMENT OF PARKS AND RECREATION  
**PRIMARY RECORD**

Page 1 of 1 Resource name(s) or number (assigned by recorder) *Foster Residence*

\*c. Address *37-647 Palm View Drive*

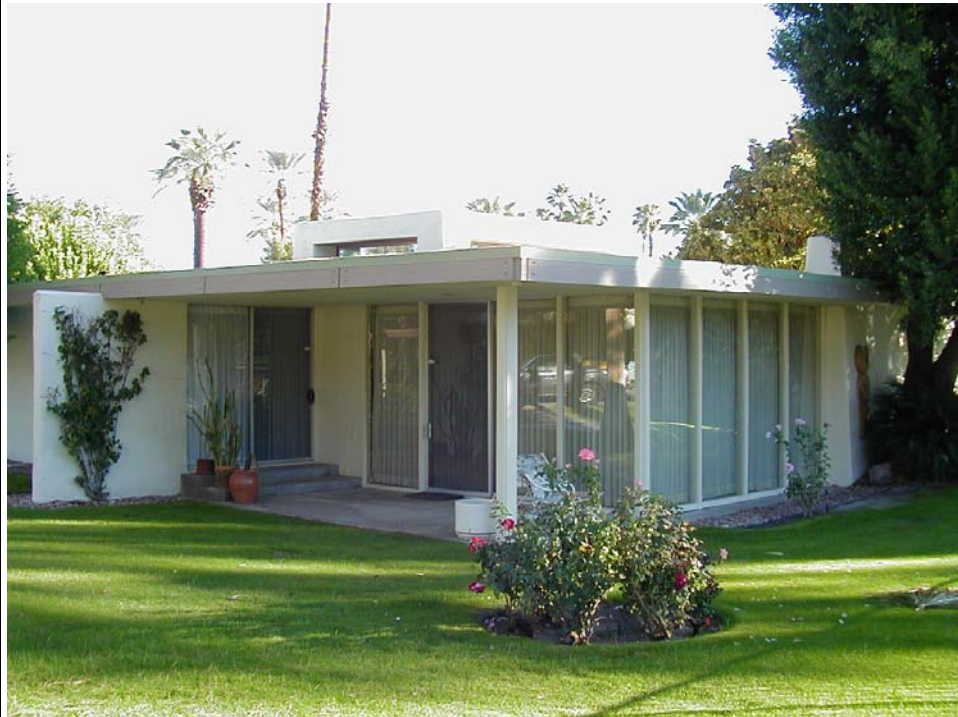
P5a. Photo

*This property is part of the Tamarisk Fairway on 10<sup>th</sup>, a cluster of eight single-family residences designed by William Cody 1969 and 1970. Although each one-story, flat-roofed house is freestanding, the buildings are zoned as condominiums because they share carports, driveways, landscaped grounds, and a communal swimming pool. Located near the 10<sup>th</sup> fairway of the Tamarisk Country Club golf course, the Foster Residence was built in 1970 and is 3494 square feet with three bedrooms and 2.75 bathrooms. Exteriors are sheathed in medium-smooth stucco and slumpstone. Deep eaves shade most elevations. Windows are aluminum-framed fixed, sliding, and floor-to-ceiling glass. A concrete entry path leads to a recessed porch entrance with double front doors. The residence is "O"-shaped with rooms oriented towards a central atrium. The battered exterior chimney is stucco-covered. The main patio is shaded by a deeply projecting roof overhang supported by a square wood post. Sliding glass doors in bedrooms open onto small private patios. The meticulously maintained park-like grounds include lawns that merge with the golf course rough. In 1994 the house was remodeled and the atrium covered with a raised, flat roof with narrow clerestories. Nonetheless, the house retains a high degree of integrity and is in good condition. The property would contribute to a potential historic district that may be eligible for listing in the National Register of Historic Places when it becomes fifty years old and could be designated under an existing or proposed local ordinance (a "4D1" National Register Status Code).*

*West and south elevations  
November 2002*
