Sample DPR Primary Record from the City's 2003 Historic Resources Survey

Page 1 of 3 Resource name(s) or number (assigned by recorder) *Ranchito Chiquito*

*c. Address *72-116 Follansbee Street*

BUILDING, STRUCTURE, AND OBJECT RECORD

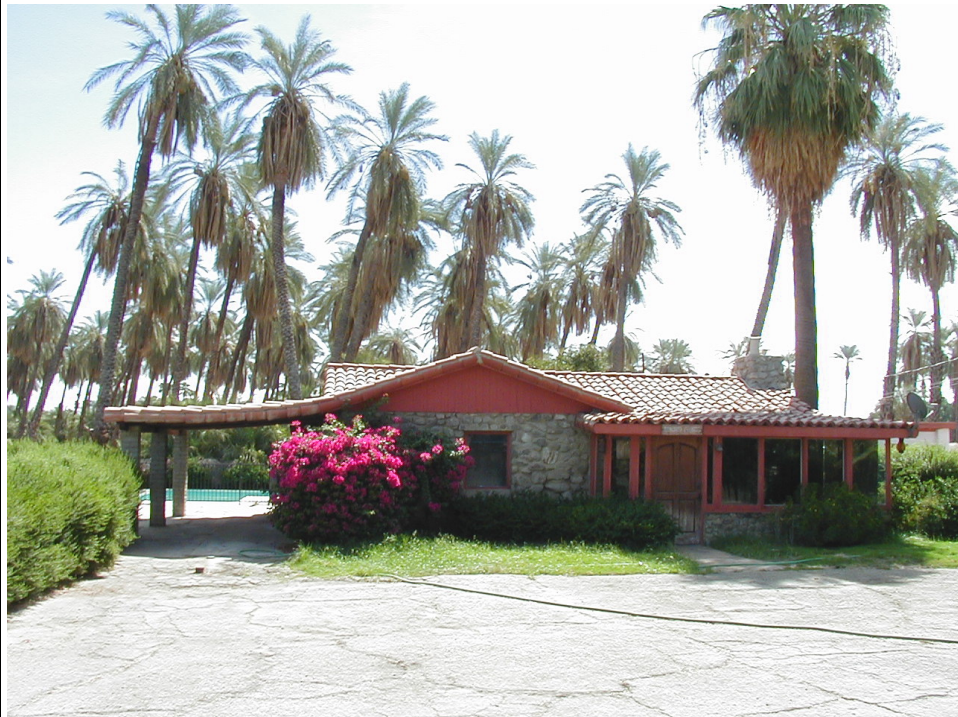
P5a. Photo

Ranchito Chiquito is a one-story rustic ranch house with Mediterranean Revival elements, located on the southwest corner of a defunct 10-acre date farm. Built in 1934, the west-facing, asymmetrical house is capped with a cross-gabled roof and comprises 1,433 square feet, with four bedrooms and 1.75 bathrooms. Original red tiles clad the roof, which gently flattens to become a porte cochere on the north side of the house. A flat, projecting shed roof covers an enclosed front porch on the building's southwest corner. The porch enclosure is not original. Exteriors are sheathed in river rock over wood frame construction. Vertical boards cover the gable faces. The west elevation features rectangular windows with wood-frames and large panes of fixed glass. A wood sign with the name "Ranchito Chiquito" is attached to the porch roof beam above the paneled wood entrance door. A trio of square concrete block posts support the porte cochere roof. On the south side of the house, a battered, exterior chimney is composed of smooth river rocks. A small swimming pool lies northeast of the residence. A brick and weeping mortar wall encloses the property along the street and the asphalt driveway fronting the house. Landscaping consists of grass, hedges, bougainvillea, and mature Washingtonia Filifera palm trees. The house appears original and is in fair condition.

*West elevation
August 2002*
